Home Systems Data Inc.
7305 E. Peakview Ave.
Centennial CO. 80111
303-773-6102

Client Information: Record Number 13003

Name, Your
123 Street Name
Denver, CO 80247

Inspected 1/11/11 9:00 AM.

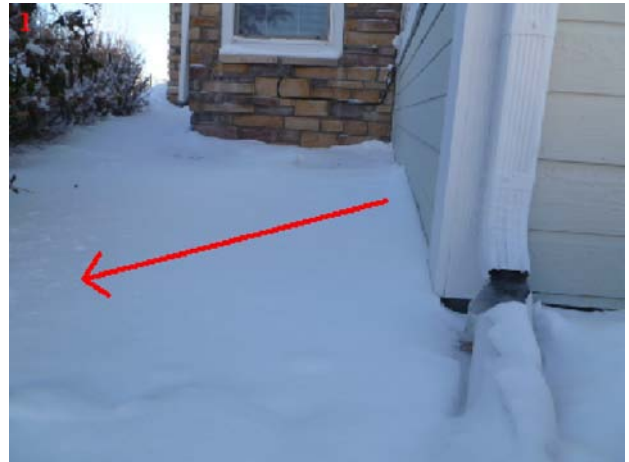
Soil should be sloped away from house to improve drainage.

Service/Repair Grading - Inadequate

Soil should be sloped away from house to improve drainage.

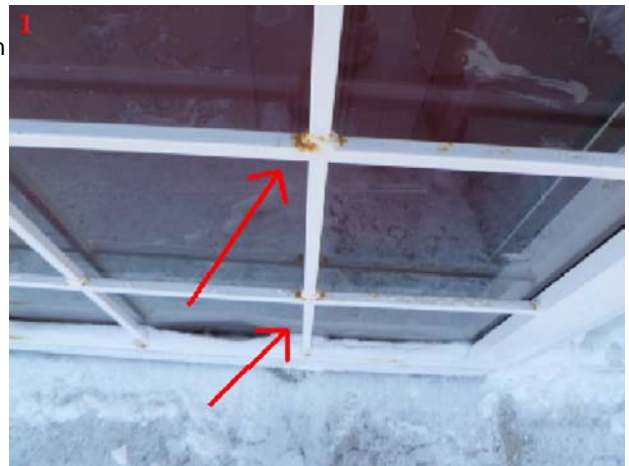
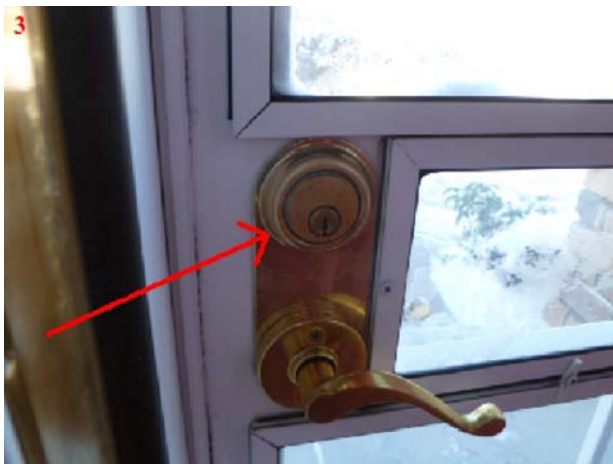
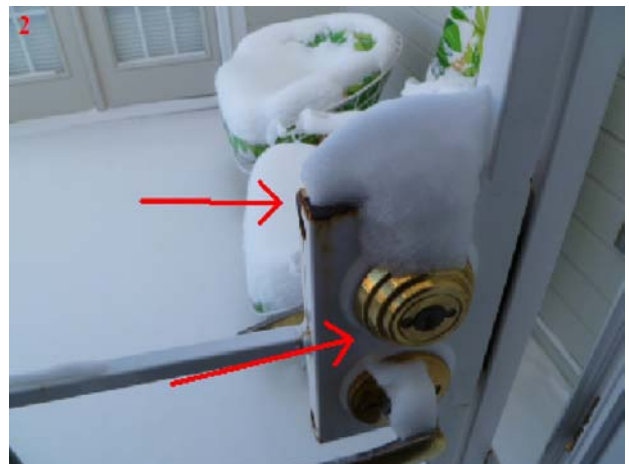
Storm Doors

Some rust was noted and should be repaired.
Double keyed deadbolts should be replaced with a thumb turn type in the event of an emergency.

Some rust was noted and should be repaired.

Double keyed deadbolts should be replaced with a thumb turn type in the event of an emergency.

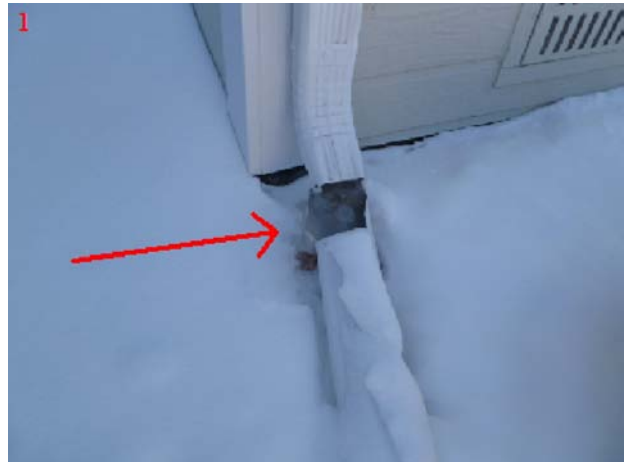
Downspout Type

Damaged extensions noted and should be repaired or replaced.

Damaged extensions noted and should be repaired or replaced.

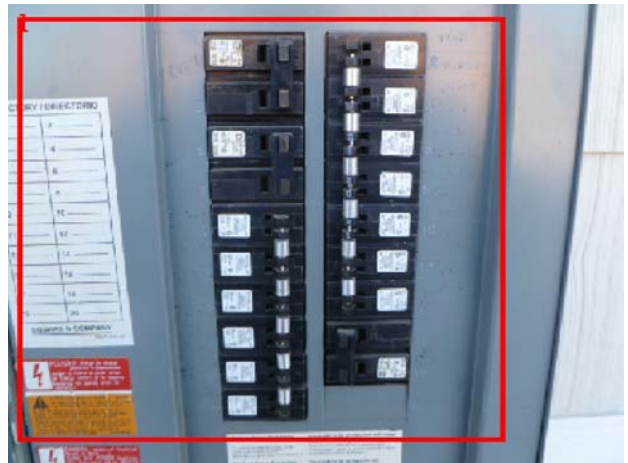
Electrical Defaults

Advise to properly label the panel.

Advise to properly label the panel.

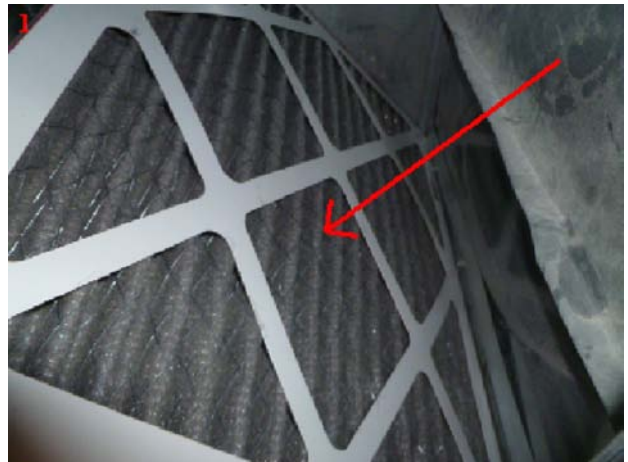
Filter System

The filter is dirty and should be replaced. Filters should be changed monthly.

The filter is dirty and should be replaced.
Filters should be changed monthly.

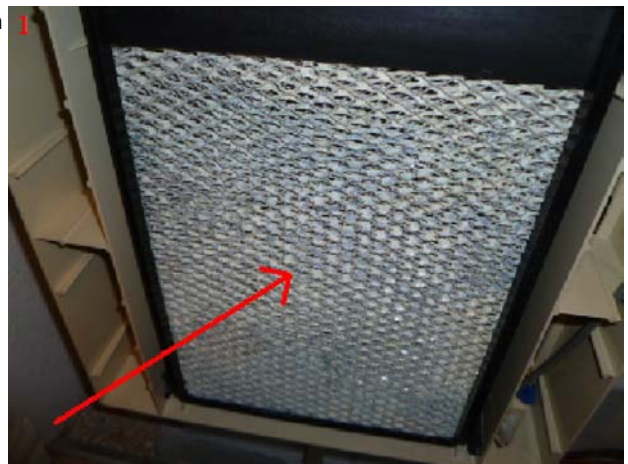
Filter should be changed at the beginning of the season, winter when unit is used. Humidifier was not tested, unit was not turned on at time of inspection, advise to have serviced by a qualified contractor.

Filter should be changed at the beginning of the season, winter when unit is used.
Humidifier was not tested, unit was not turned on at time of inspection, advise to have serviced by a qualified contractor.

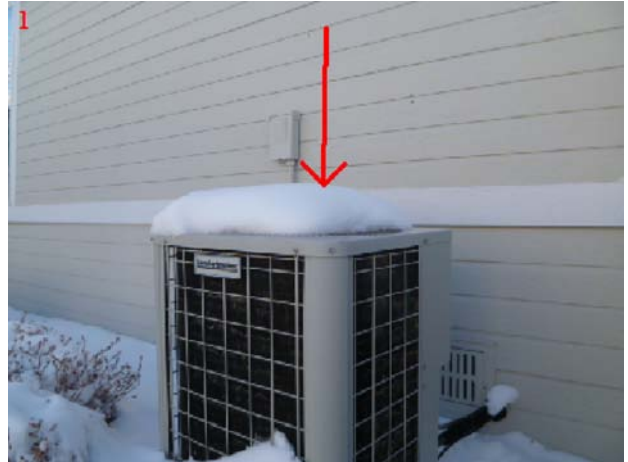
Cooling System 1 Brand

The unit should be leveled.
The outside temperature was too low and unit could not be safely tested. Operating A/C units below 60 degrees in the cooling mode below 65 degrees can damage the compressor so the unit was not tested at time of inspection.

The unit should be leveled.
The outside temperature was too low and unit could not be safely tested. Operating A/C units below 60 degrees in the cooling mode below 65 degrees can damage the compressor so the unit was not tested at time of inspection.

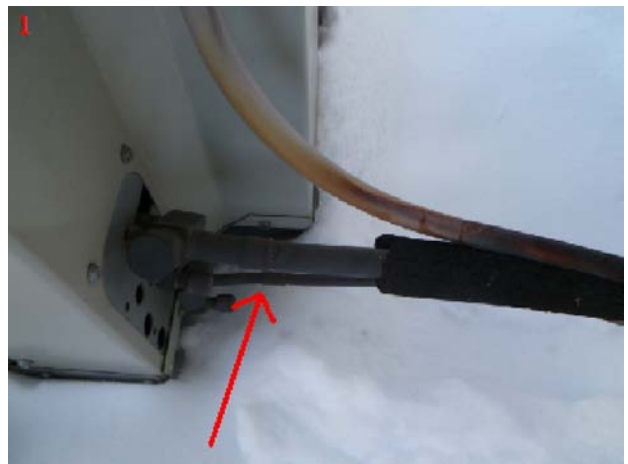
Cooling Lines

The insulation should be improved.

The insulation should be improved.

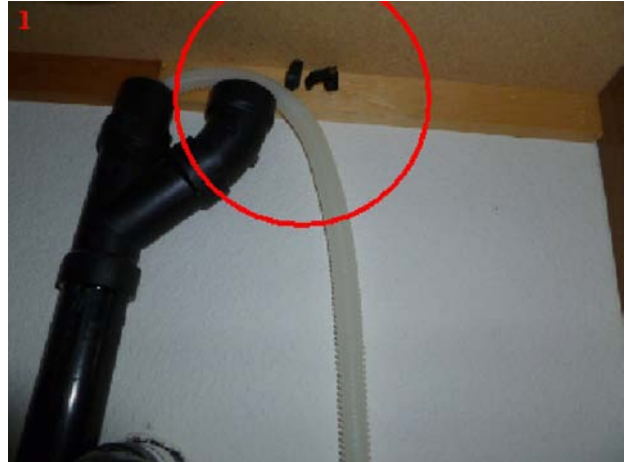
Dishwasher Mfg.

Dishwasher drain line should be secured to the cabinet or the stand pipe.

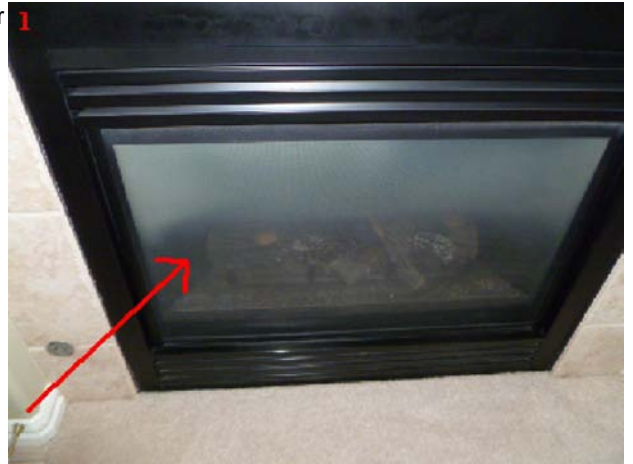
Interior Fire Place 1

The fireplace should be cleaned and serviced, servicing may uncover defects not readily visible during the inspection.

The fireplace should be cleaned and serviced, servicing may uncover defects not readily visible during the inspection.

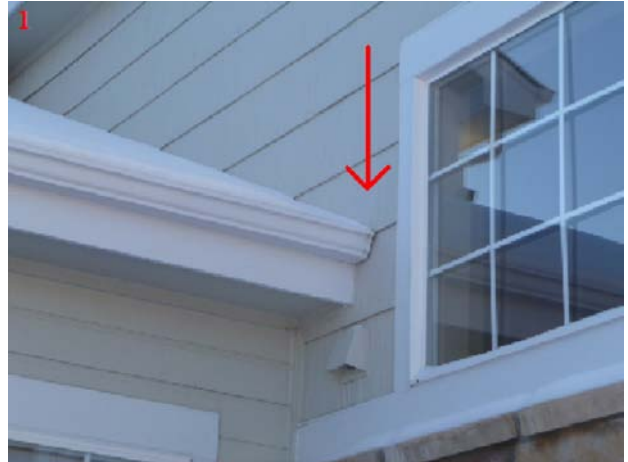
Siding

Missing kickout flashing noted at the ends of the gutters.(Diverter)

Missing kickout flashing noted at the ends of the gutters.(Diverter)

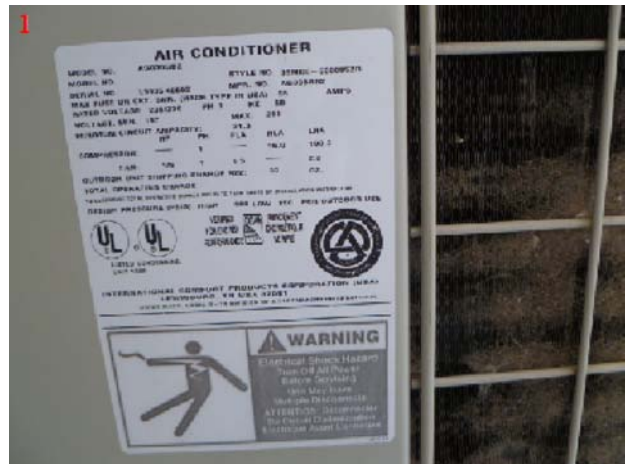
COOLING SYSTEM

Documenting photo of serial/model number
